Report No: 2020R087

Carharrack Methodist Church, Cornwall

Heritage Impact Assessment

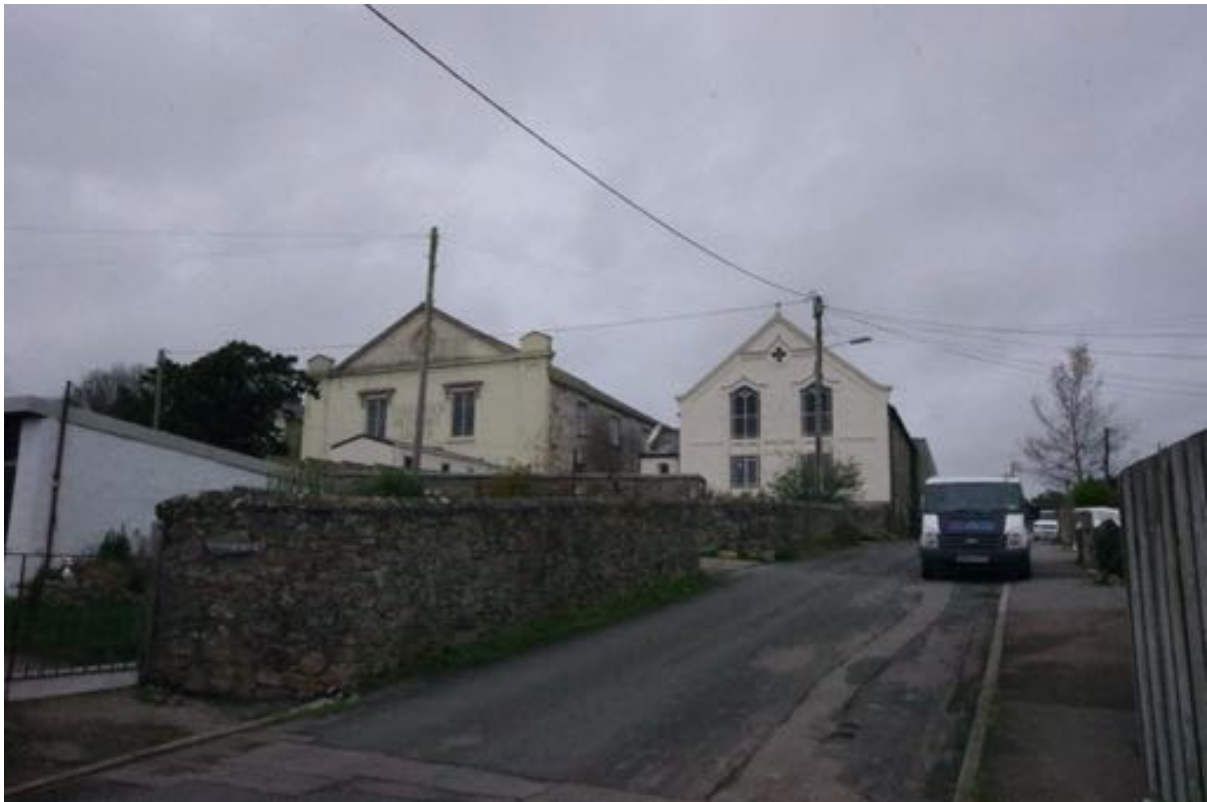
Fig 6 Carharrack Methodist Church (left) and Sunday School (right) as viewed from the road.

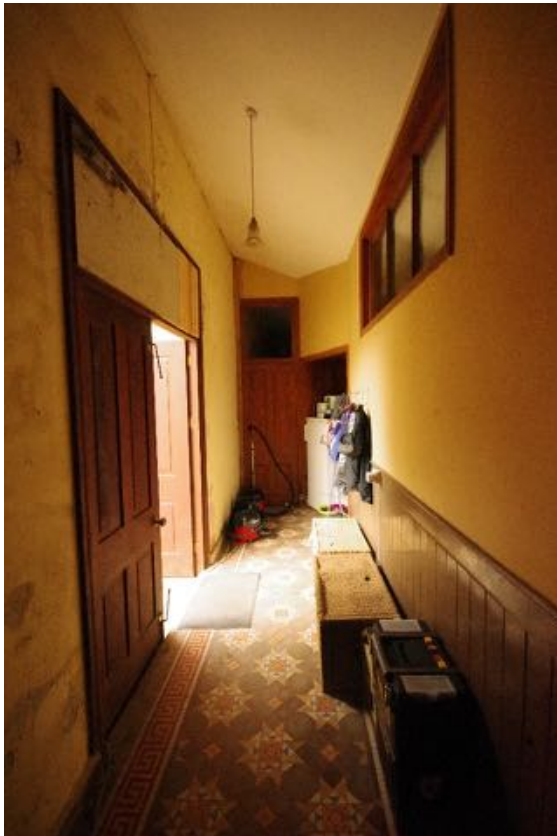
The interior of the church is accessed via double, four-panelled doors via a foyer (Room 1, Fig 7). In both the east and west walls of the foyer there is a four-panelled door with transom light above, leading to a staircase on either side. At the east and west ends of the north wall there are recessed felted double doors with panelled reveals. There are borrowed lights at the top of the north wall. The felt-covered doors give access to the main chapel (Room 2GF/2FF, Fig 8). At ground floor level there are 19th century pews, some with ceramic number plates (Fig 9) and brass fittings. The east and west walls are flat plastered and contain regularly spaced original window openings, the lights having rounded heads (Fig 10). To the north there is a later 19th century rostrum (Fig 11) which has a communion rail to the front. The pulpit has a trefoil headed blind arcade in the lower half, in the upper half there is a Romanesque blind arcade at the centre and trefoil-headed arcades on either side. This is flanked by simple staircases with turned newel posts. Either side of the pulpit there are panelled doors with decorative glazing in their upper halves (Fig 12) and the east and west walls are panelled at the base with multi-pane glazing in their upper halves. In the upper part of the chapel at first floor level there is a horseshoe gallery supported on timber Tuscan columns running around the east, south and west walls. The gallery has a simple panelled balcony front and contains three rows of box pews all the way round (Fig 13). The early 19th century box pews have panelled doors with H-hinges (Fig 14). At the north end of the room there is an organ with decorated pipes (Fig 15). Either side of the organ there are timber panelled partitions (Fig 21). In all of the walls at first floor level there are original, square headed window openings containing windows with round-headed lights. The windows in the south wall contain stained glass (Fig 16). The ceiling is flat with floral decoration, ventilation and exposed timber joists.

Fig 7 Foyer looking west.

Room 1 **Renovate front doors.**

Impact: sympathetic and minimal restoration of the doors will have a positive impact in improving the character of the building and will contribute to the character of the WHS.

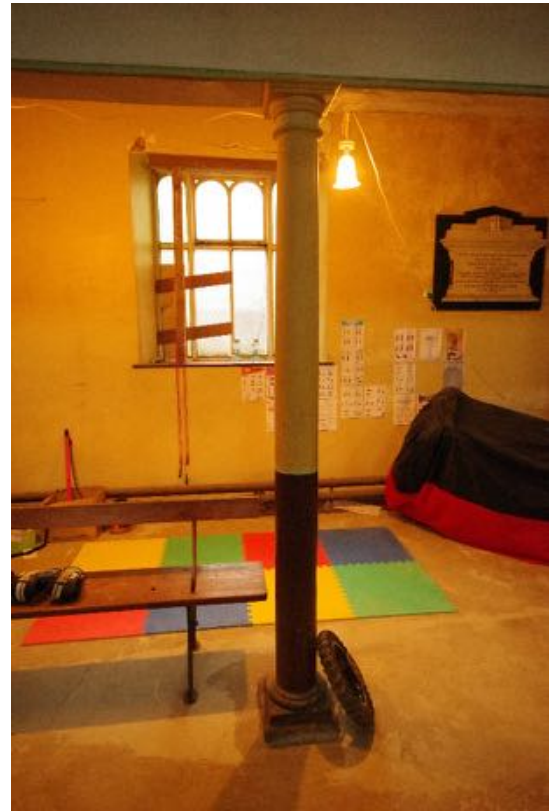
Fig 10 Detail of column and ground floor window.

Insert secondary double glazing in window openings.

Impact: The installation of secondary glazing will have a negative impact on the character of the interior.

Mitigation: A less intrusive method of preventing drafts would be to use insulation tape.

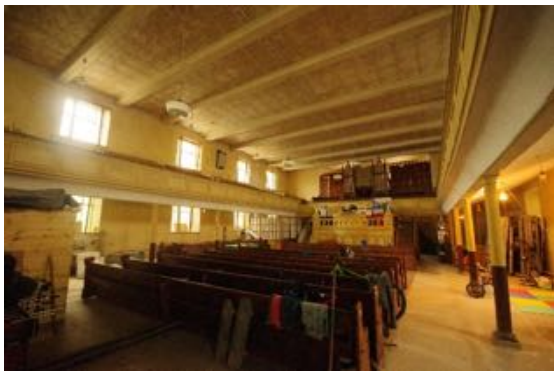
Fig 8 Chapel interior.

Remove pews, retaining a small number of rows to the south of the chapel, positioning several around the outside of the room and using the remaining timber in the conversion works.

Impact: The removal of internal fittings will have a negative impact upon the historic fabric of the building and also on its historic character and plan-form.

Mitigation: The retention of several rows of pews at the south end of the chapel will allow the understanding of the interior to be retained, but will not mitigate against the loss of historic fabric, character and plan-form. The reuse of pews around the edge of the room and the reuse of the timber will allow the space to retain an indication of its former character prior to conversion.

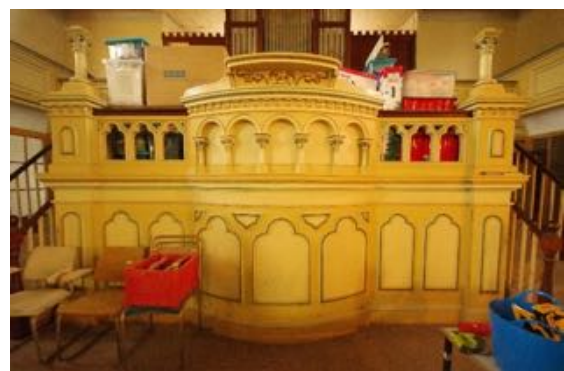
Fig 11 Detail of rostrum.

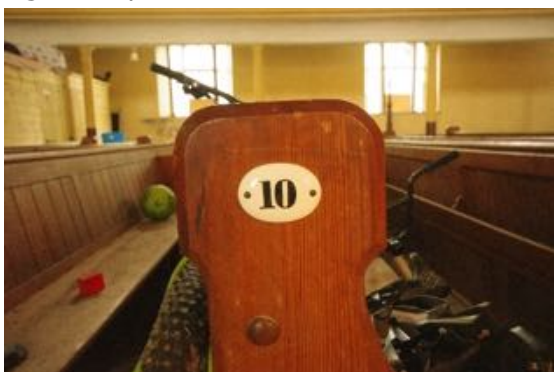
Fig 9 Detail of ground floor pew.

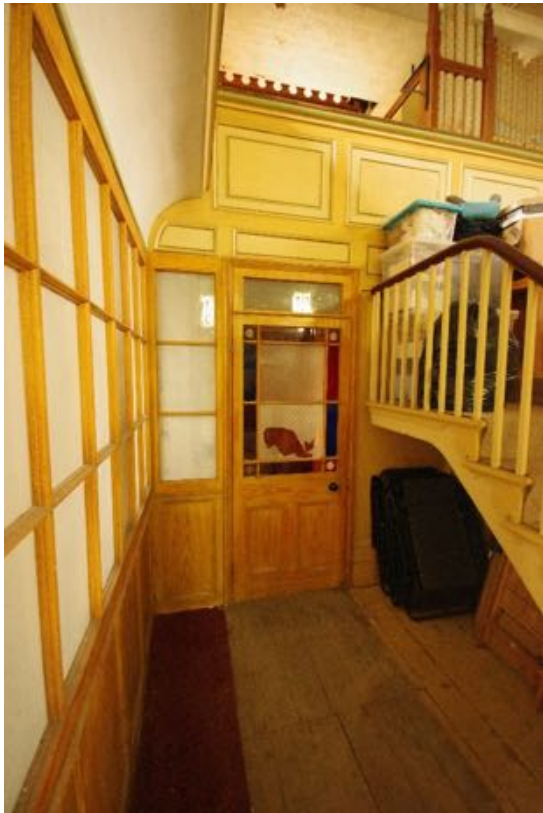
Fig 12 Glazed door with coloured glass, glazed partition to the left and balcony frontage .

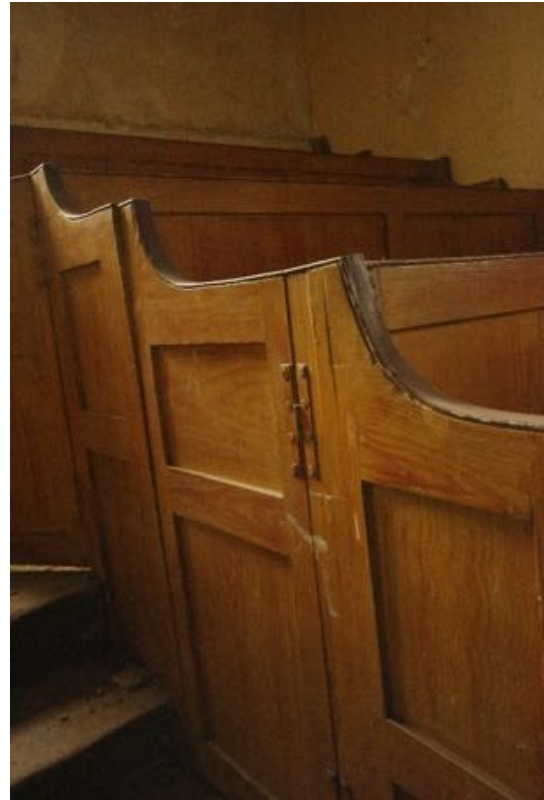
Fig 14 Box pews which are proposed to be removed and used in the restoration of the remainder of the gallery.

Renovate box pews in gallery using those removed for the insertion of the bedroom and bathroom.

Impact: The alteration of any of the box pews will have a negative impact, however the restoration of the majority which are to be retained will have a positive impact in improving the character of the remaining gallery. It is understood that the pews that are proposed to be removed have been subject to extensive vandalism, hence the proposal to use this space for the alteration.

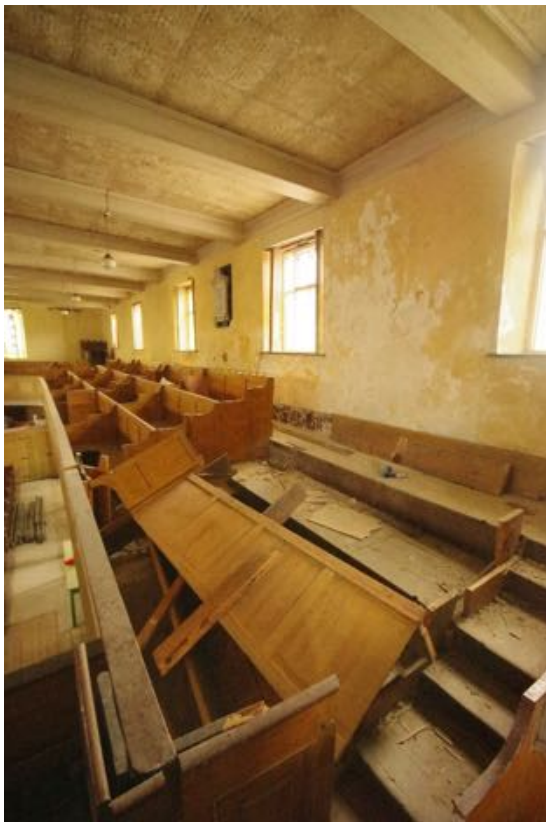
cover and under-sized rainwater goods has resulted in structural issues with the window lintels and floor of gallery. Damage has been caused to the gallery box pews which are some of the oldest remaining in Cornwall. Positive discussions continue with the owner and local planning authority regarding future use.

Fig 13 Damaged early 19th century box pews.

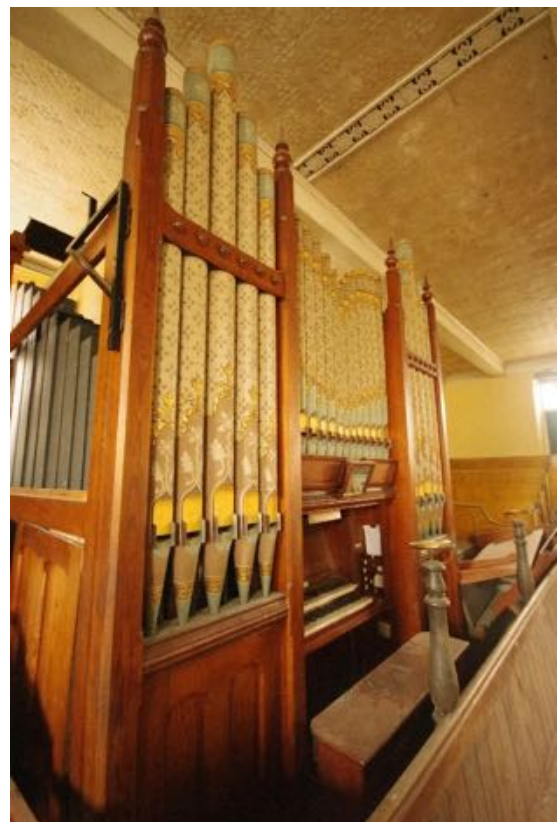
Fig 15 Organ situated above the rostrum. The organ frontage is to remain visible from the main church space.

Room 2 (FF) Insert partition walls in line of northern gallery, forming a bedroom and bathroom, and resize organ.

Impact: The insertion of additional rooms will negatively impact the historic planform of the church which is largely unaltered. It will also have a high negative impact on the historic fabric of the building, in particular to some of the early 19th century box pews, however it is understood that these pews have been subject to extensive vandalism (see proposal for restoration to other pews below). The alteration of the organ will have a negative impact on the historic fabric.

Mitigation: The design of the new walls to the south are to match the existing late 19th century panelled partitions with decorative coping which currently flank the organ. This will allow the impression of the current arrangement of rostrum, organ and panelled partitions to remain. The window openings within the partitions are to match the existing style of those in the chapel. This will help to minimise the impact on the character of the interior. The existing partitions could be retained in position as the proposal plans show new walls in these locations. If this is not possible the material should be reused in the construction (either structurally or cosmetically) of the new partitions in this position. The existing balcony front should be retained in its current position. While it will be damaging to the fabric to remove the organ, it is understood that Historic England have accepted its removal. Therefore a compromise is to keep to frontage of the organ in place to retain the character of the interior but to remove the inner workings of it to provide additional room for the occupancy. It is understood the intention is that the parts removed will be given to an organ specialist for use in other restoration projects.

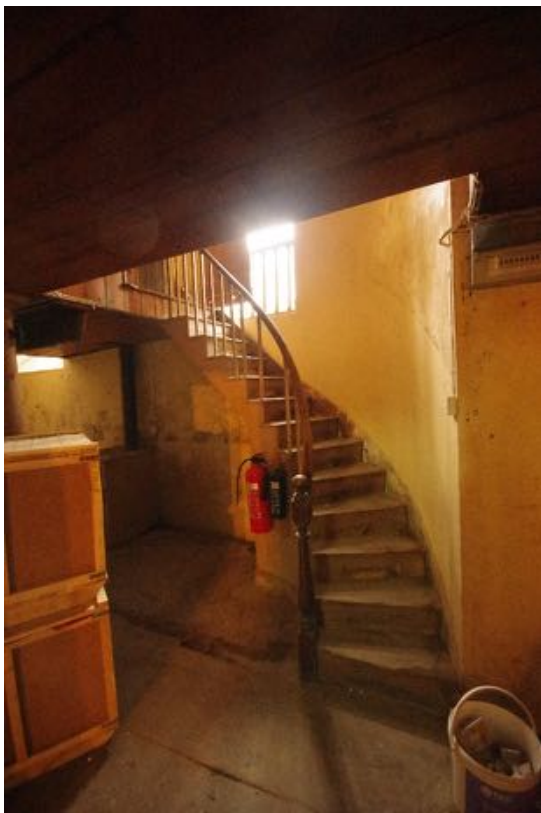
Fig 17 Curved timber staircase behind rostrum.

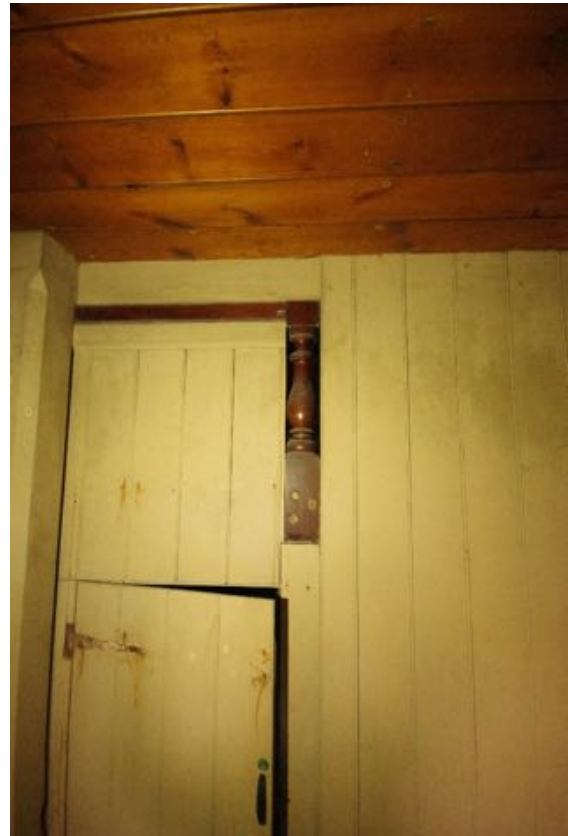
Fig 18 Remains of earlier rostrum or pulpit within the rear of the current late 19th century arrangement.

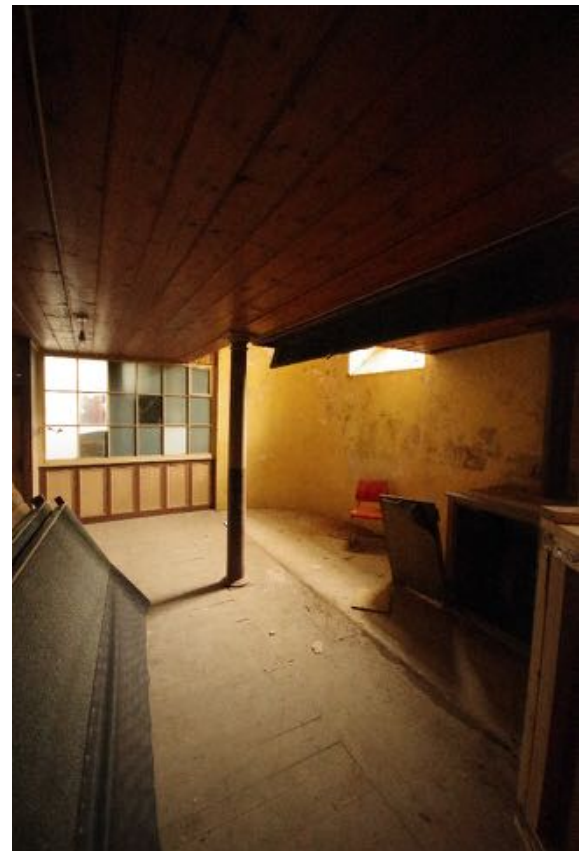
Fig 19 Apse space which is the proposed site of the kitchen.

Insert kitchen fittings.

Impact: Insertion of the kitchen fittings will have a negative impact on the character of the building and minimal negative impact on the fabric of the building.

Mitigation: The impacts can be reduced by using materials and finishes that match those existing within the room.

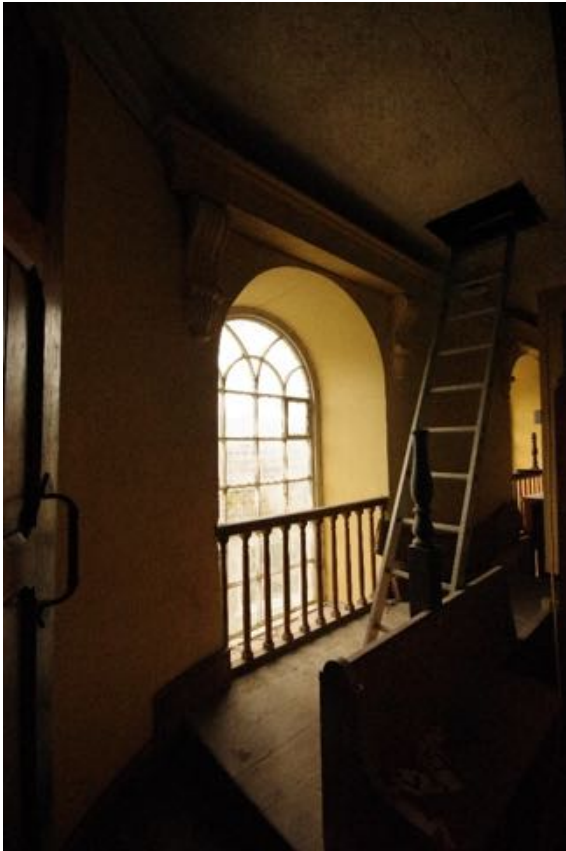
Fig 20 Space behind the organ showing original window in the apse with decorative consoles and entablature over the opening.

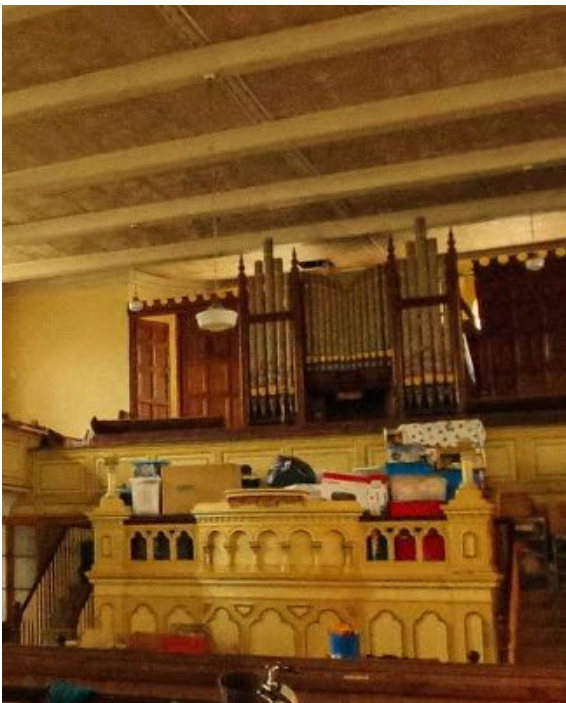
Fig 21 View of the timber panelled partition located beside the organ.

Mitigation: The impacts can be mitigated by mirroring the designs and materials used on the west side of the organ chamber – timber dados and multi-paned glazing above.
